Manhole Inspection Summary

Manhole # S67U__007MH

Insp Date: **3/13/08 9:48 AM**

Location Address: **6300 Seaforth St.**

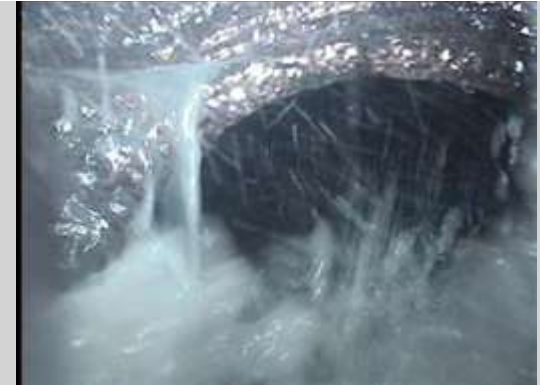
12 O'Clock Outflow

Comments **INCOMING 6 O'CLOCK BOTTOM DROP IS BLOCKED CAUSING OVERFLOW OUT TOP DROP LINE.**

Clogged drop is causing flow to come down on out.

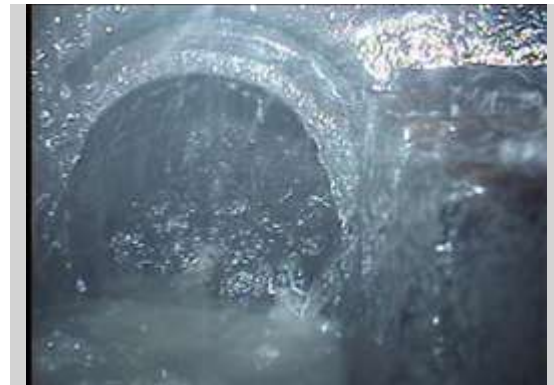
Drop In @ 6 O'Clock

Drop Condition: **Clogged**
